**ASBESTOS AND LEAD BASED PAINT  
SURVEY**

*Project Site:*  
**OMC Plant 2**  
**100 East Sea Horse Drive**  
**Waukegan, Illinois**  
*Project # 1515.007.01*

December 14, 2007

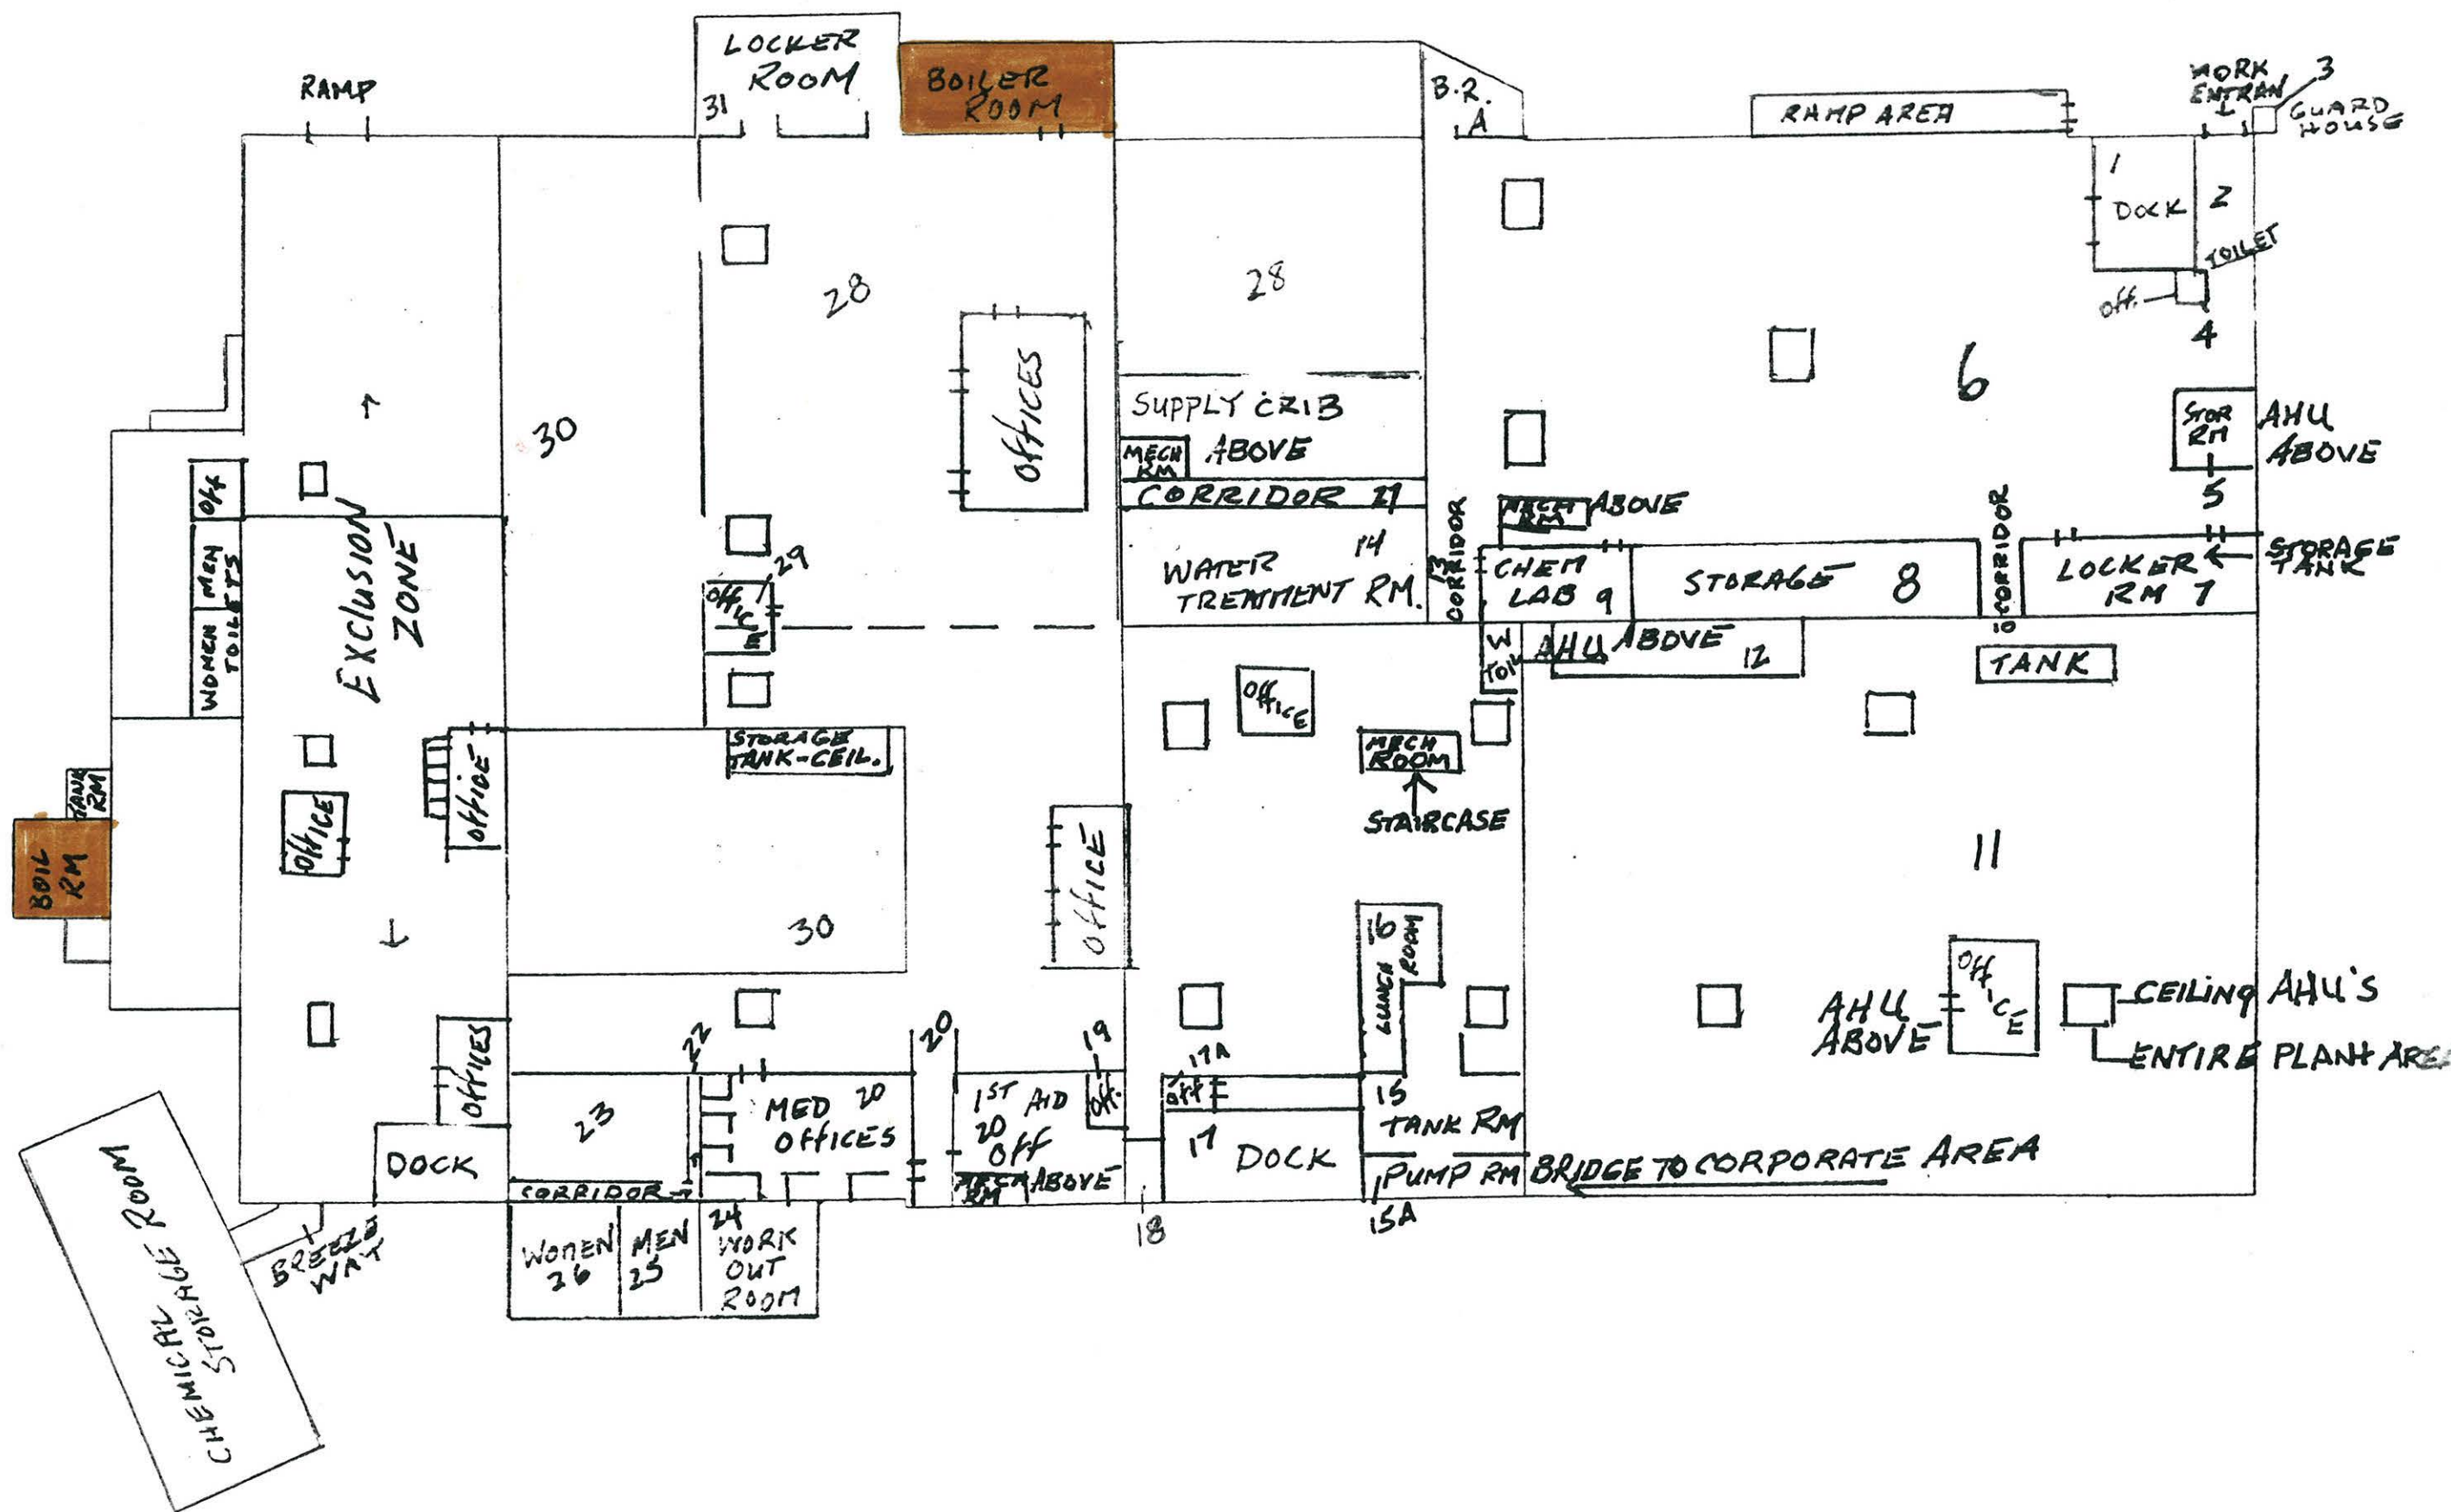
DRAWN BY: DM/LWS	APPROVED BY: D.Mc.	TITLE: Boiler Door Gaskets
DATE: 10/31/07	PROJ. NO.: 1515.007.01	
DWG. NO.:	DWG.

AHU Access Door Gaskets	Mechanical Rooms	72 L.F.
Furnace Door Gaskets	Area 11 Near offices Col. 192 Washers 1 & 2	126 L.F.
Storage Tank A TSI	Ceiling area by Exclusion Zone	250 S.F.
Storage Tank C TSI	Tank in Locker room 2	250 S.F.
Corrugated Exterior Transite Panels	Throughout all elevators	65,000 S.F.
Flat Exterior Transite Panels	Throughout all elevators	65,000 S.F.
Caulk on Aluminum Siding	West Elevation	1,500 L.F.
Caulk on Large Concrete Blocks	Seams of Concrete Foundation Blocks along Exterior Perimeter	1,150 L.F.

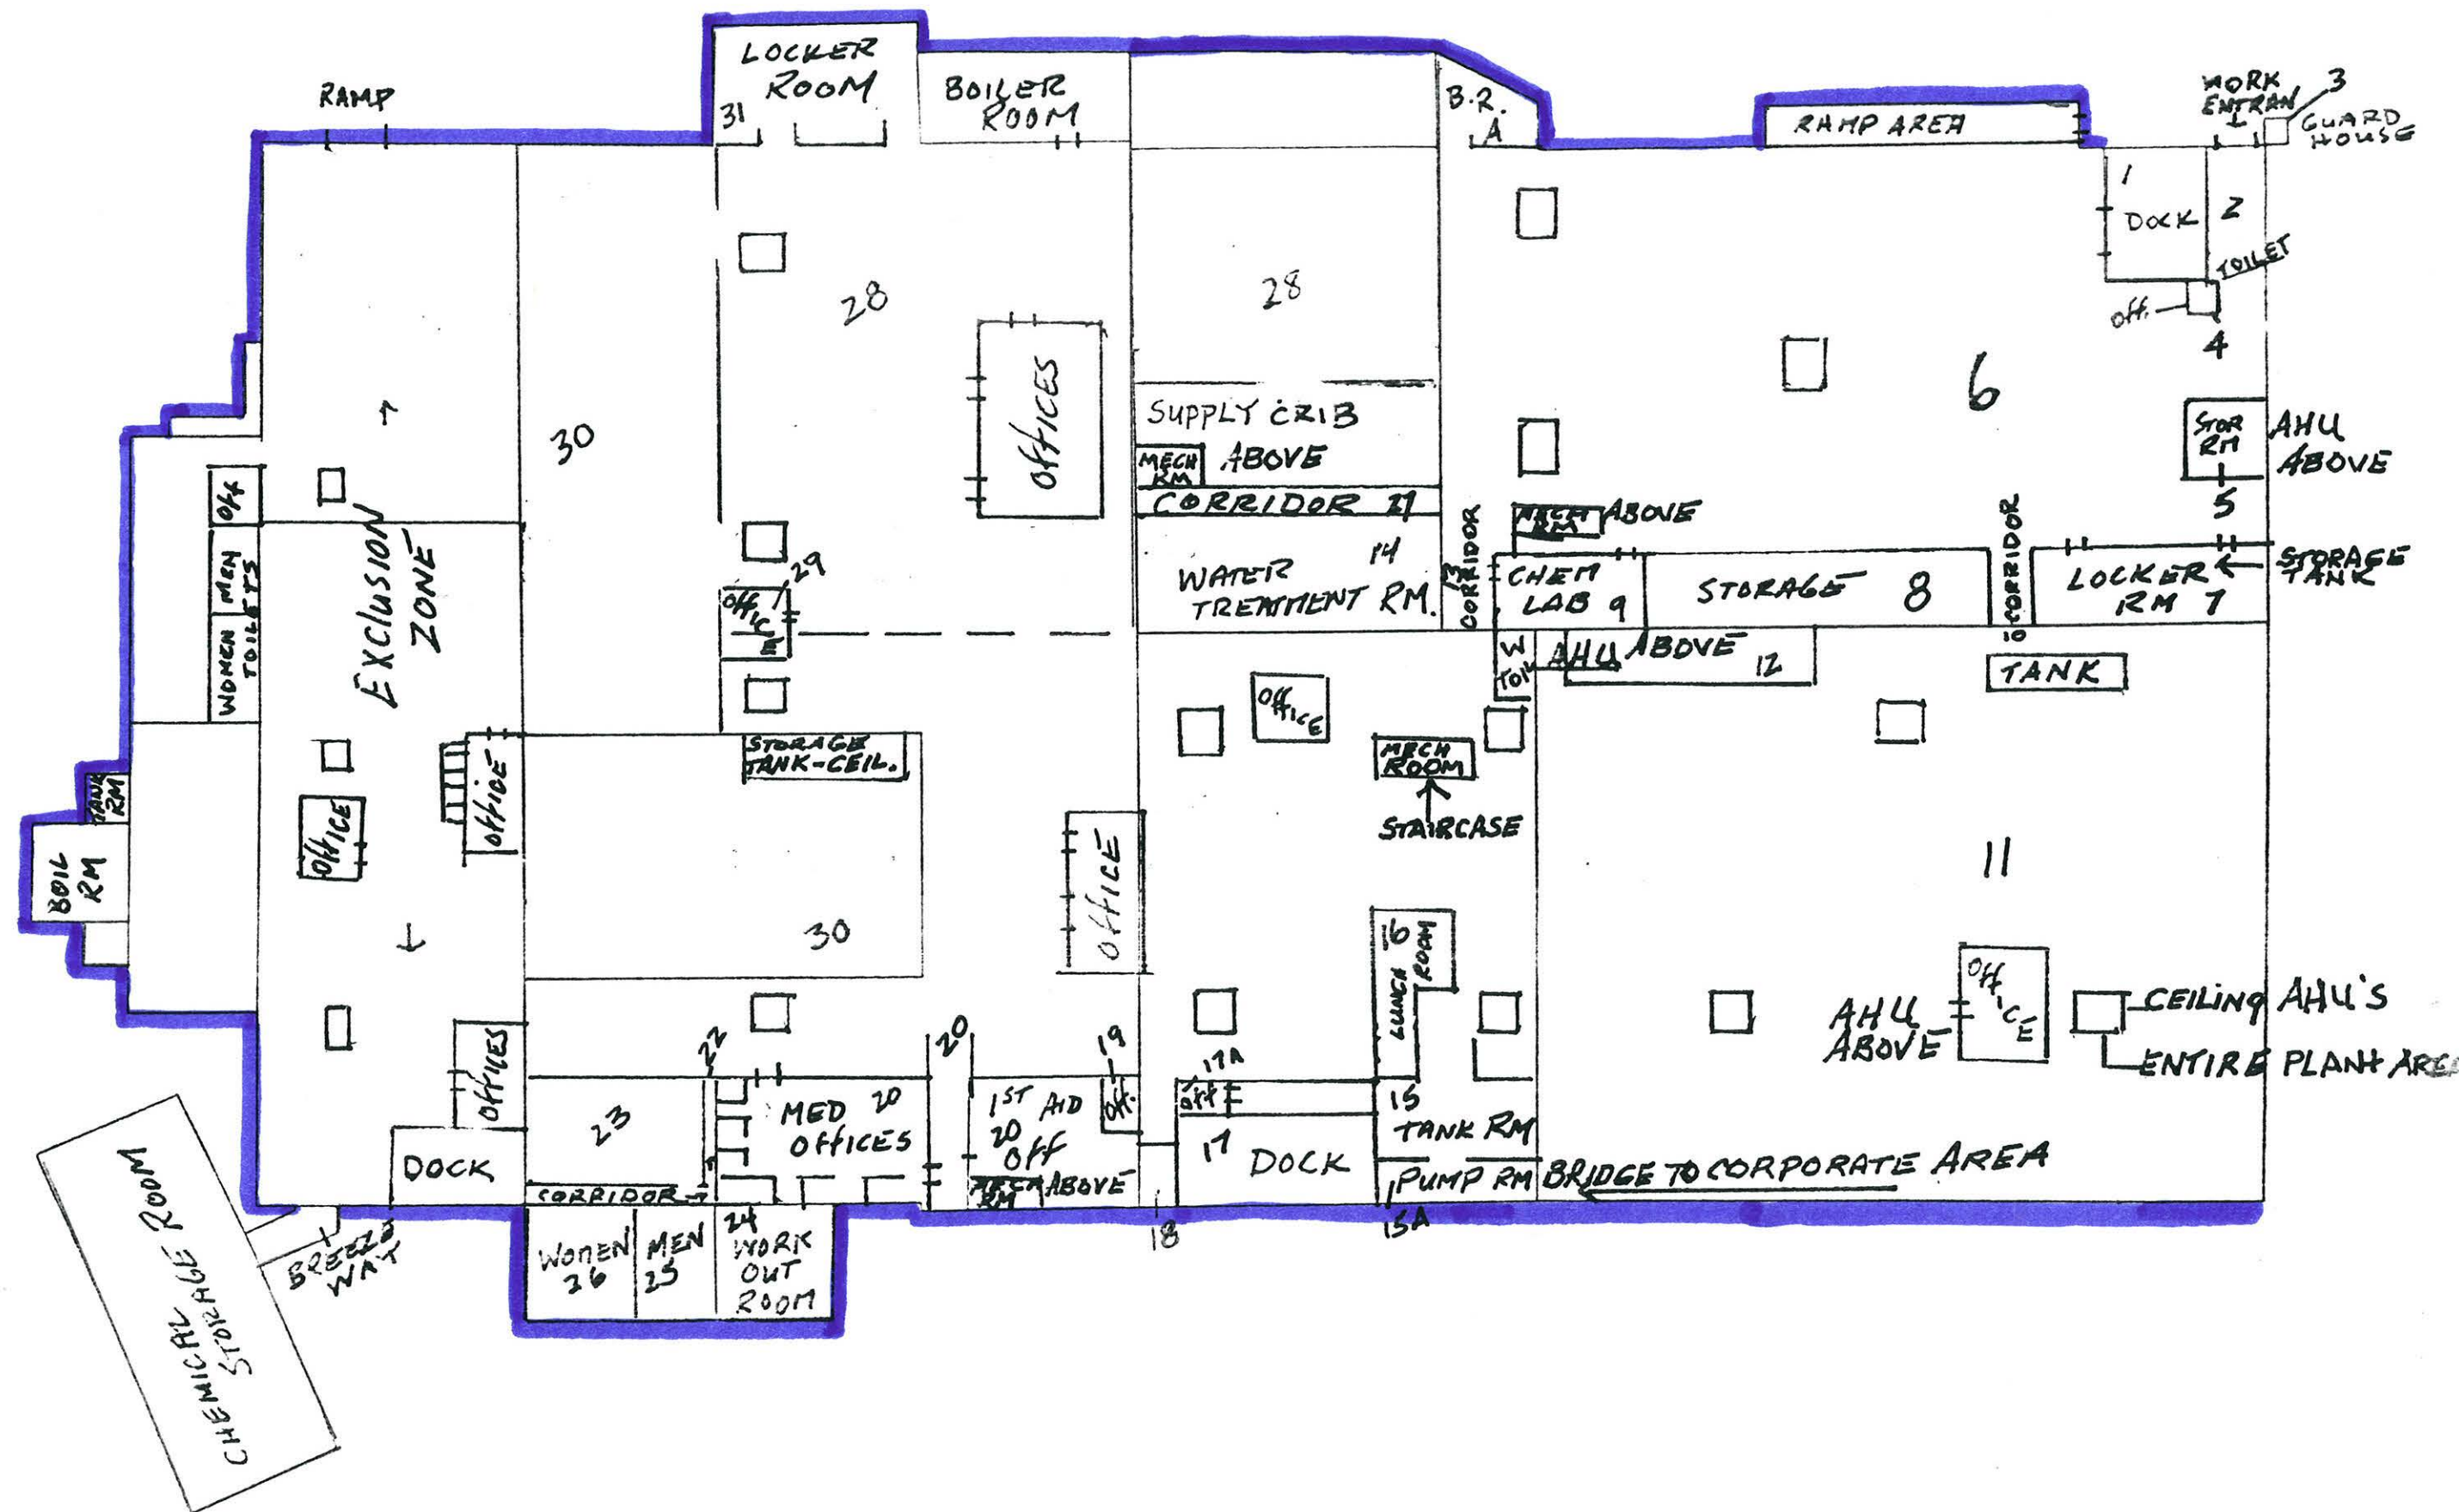
DRAWN BY: DM/LWS	APPROVED BY: D.Mc.	TITLE: Caulk and Expansion Joints
DATE: 10/31/07	PROJ. NO.: 1515.007.01	on Large Concrete Blocks
DWG. NO.:	DWG.

Material	Material Locations	Estimated Quantity
Expansion Joints on Large Concrete Blocks	Seams of Concrete Foundation Blocks along Exterior Perimeter	1,150 L.F.
Caulk on Metal Trough	East side of Building on Exterior near Overhead Garage Doors	25 L.F.
Door Caulk	Exterior doors of all elevations	300 L.F.
Overhead Garage Door Caulk	Exterior Door of All Elevations	650 L.F.
Ventilation Grill Caulk	East side of Building on Exterior	50 L.F.
Metal Building Roof Drain Caulk	Former Hazardous Waste Storage Building Along Roof Level	25 L.F.
Glass Door Frame Caulk	South Elevation	40 L.F.
Window Caulk on Large Multi-Pane Windows	All Elevations	5,255 LF
Window Glazing on Small Windows	All Elevations	56,600 LF
Gasket on Exterior Upright Tank	East Side of Building Exterior	1 EA
Green Debris Near NW Ramp	North Side near Bottom of Ramp to Building	25 S.F.
2" Cardboard TSI	Area 1 Mobile Office, Risers by access roof assoc with AHU ceiling pipe.	2,100 L.F.
